NRL MEMORANDUM REPORT No. 192

FINAL REPORT ON ENGINEERING EVALUATION OF SCANNING SONAR EQUIPMENT MODEL QHD SERIAL NO. 1

H. H. Elliott, Jr. SOUND DIVISION

20 July 1953

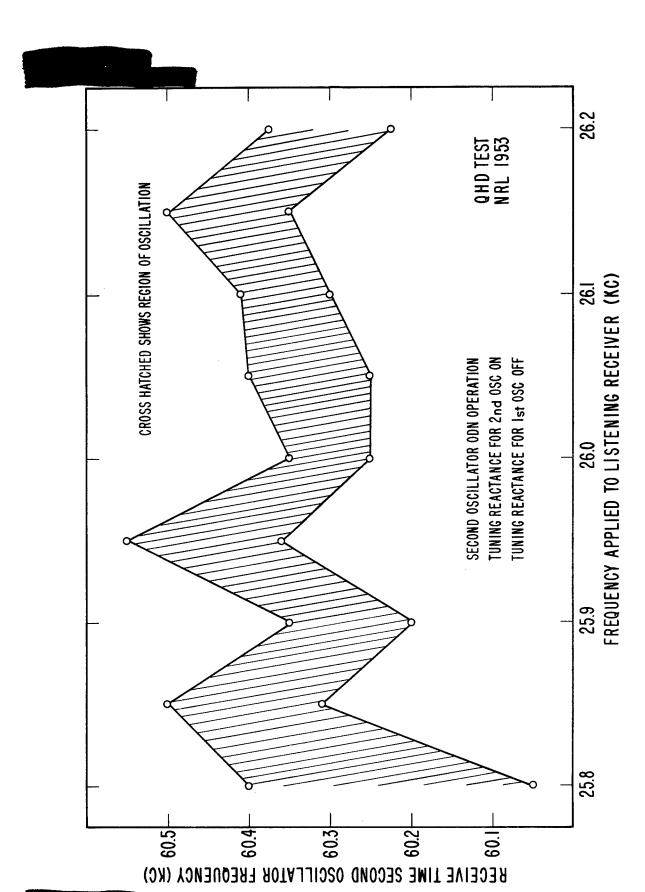
FIGURE 9

- z. When the oscillator load impedance was changed ± 25 percent, there was no significant change in the oscillator frequency.
- The frequency of the second oscillator is controlled by the a.a. . listening receiver output frequency by means of the discriminator rectifier and tuning reactance tube when the second oscillator ODN tuning reactance is on. This output frequency is in turn determined by the receiver input frequency, the first oscillator frequency, and the second oscillator frequency. However, when the QHD system was under operating conditions of normal echo ranging, it was found that the second oscillator frequency was not controlled by the receiver input frequency. The apparent reason for this is the transient noise produced in the listening receiver caused by the change from transmit time to receive time operation. Since the tuning reactance tube samples the output of the discriminator rectifier immediately after the transmitted pulse, the tuning reactance tube receives a voltage according to the frequency of the transient noise in the listening receiver and not the reverberation frequencies received. As a result, the second oscillator frequency was not determined by the frequency of the signal received but wandered over a range of three hundred cycles continuously. (See Fig. 9.) Occasionally, the drift was greater than four hundred cycles and oscillations stopped altogether. Without the second oscillator frequency, the listening receiver and the scanning receiver were inoperative.

Fig. 57 shows the second oscillator frequency variation as the temperature was changed, with the tuning reactance "on". The values shown are not a true indication of the oscillator frequency as its frequency varied continuously in a manner as shown in Figure 9. Also, notice that the operating frequency was approximately 1000 cycles below the correct second oscillator frequency. This erratic operation was not an effect of the temperature test but was due to noise in the listening receiver during the change from transmit time operation to receive time operation. For further explanation of the incorrect second oscillator tuning reactance operation,

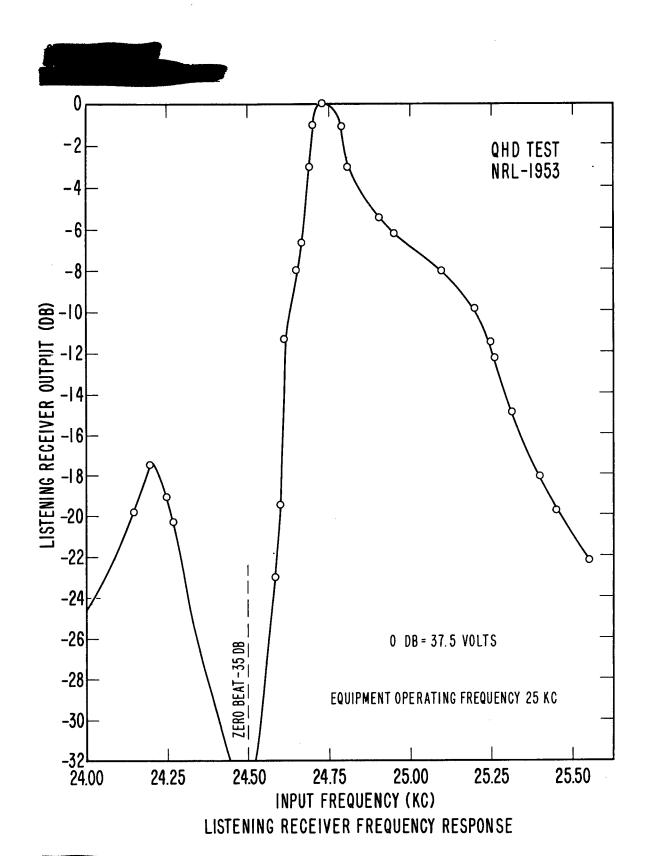
FIGURE 11

- dd. The amplifier section has one channel which is used for all pulse lengths.
- ee. The maximum voltage gain of the amplifier was 134 db. At full gain, the amplifier overloaded when 40 microvolts were applied to the input. Overload characteristics are shown in Fig. 10. The pass band of the amplifier at the 6 db down points was 250 cycles either side of the operating frequency. For the entire frequency characteristic of the amplifier, see Fig. 11.

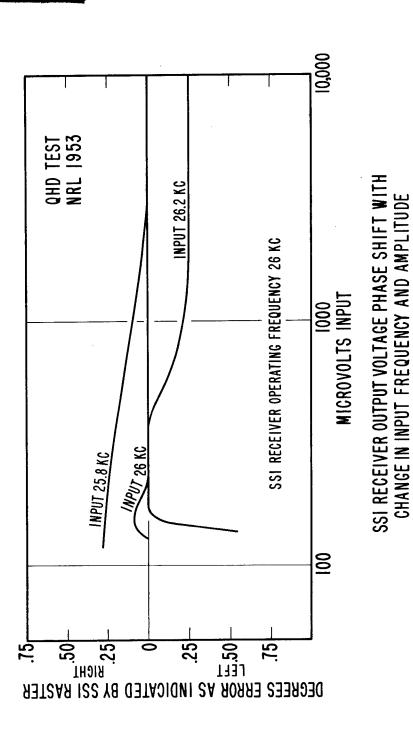
FIGURE 16

- mm. The effects of various combinations of RCG and TVG on the receiver gains are shown in Figures 5, 6, 7, 12, 13 and 14.
- nn. The SSI Receiver is a two-channel amplifier, the right channel being exactly the same as the left. The voltage gain of each channel was approximately 100 db at the lowest input voltage level that would cause the blocking oscillators in the output of the channels to operate. However, the voltage from the blocking oscillators remained constant as the input signal was increased. The maximum phase shift between the output voltages of the two channels when the input frequency was as much as ± 200 cycles away from the correct operating frequency, and the input signal was varied from the threshold of operation to overload was ± 1/2 degree as indicated by the raster of the SSI CRT. See Figure 16.

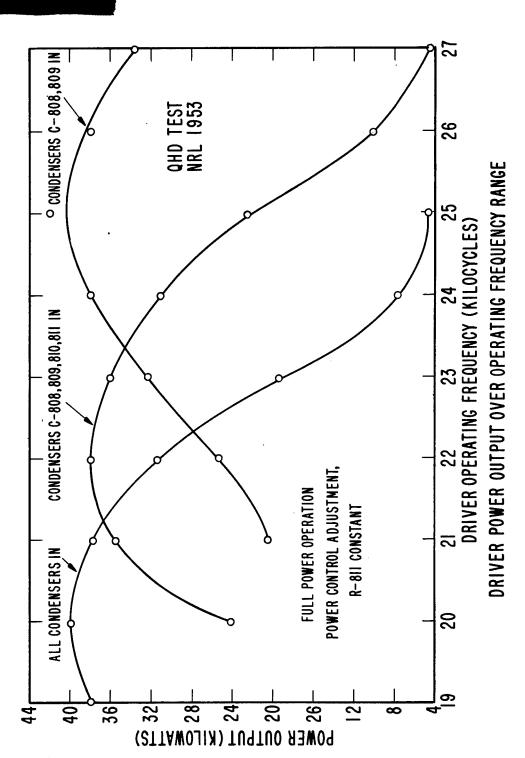
FIGURE 17

- b. Figure 17 shows the frequency characteristics of the driver with various tuning capacitors used.
 - c. The power output of the driver at the end of a 35-millisecond pulse did not decrease by more than 10 percent of the maximum value.

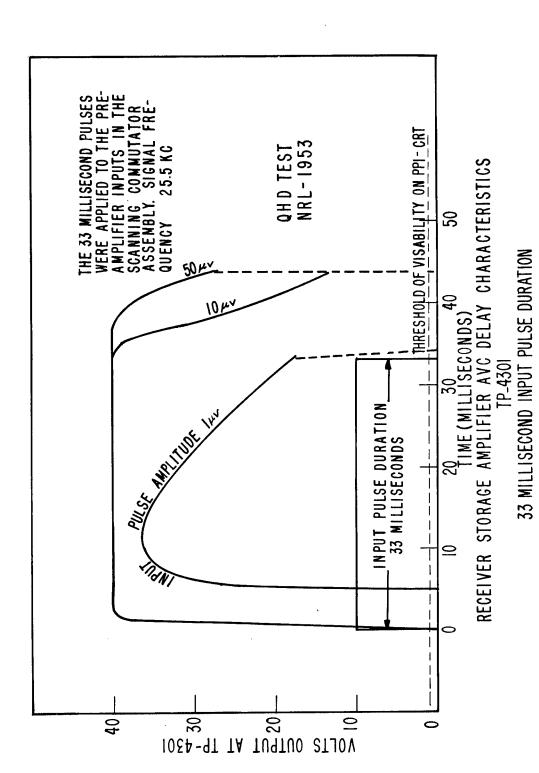
FIGURE 47

As seen on Fig. 47, the signal output from the storage scanner under normal operating conditions was forty times greater than required to produce a recognizable display on the PPI CRT. This characteristic produced a very definite target display on the PPI tube.
